SCHOFIELD BARRACKS MILITARY RESERVATION,
ORDNANCE STOREHOUSE BUILDING 2109
South of intersection of Kolekole Avenue and Cadet Sheridan Road
Wahiawa Vicinity
Honolulu County
Hawaii

HABS No. HI-544-H

# PHOTOGRAPHS WRITTEN HISTORICAL AND DESCRIPTIVE DATA

## SCHOFIELD BARRACKS MILITARY RESERVATION, ORDNANCE STOREHOUSE BUILDING 2109

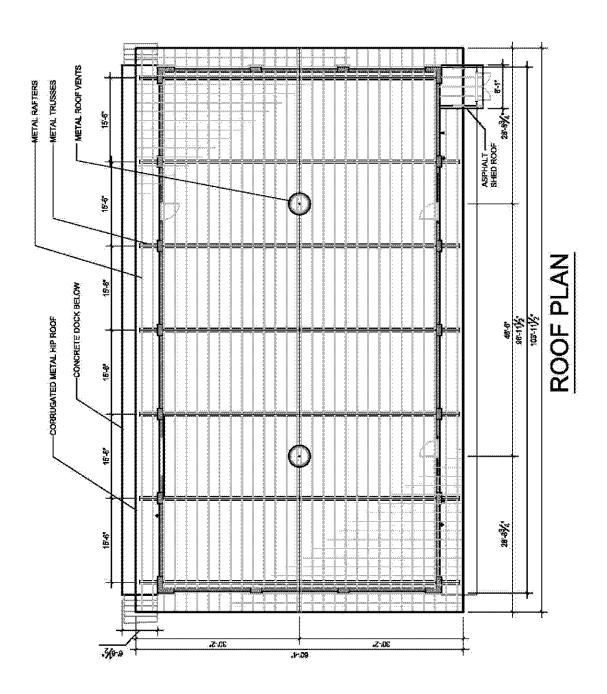
Drawing of ordnance storehouse building dated June 28, 2010 showing the exterior roof plan, typical of ordnance storehouse buildings. Note that some of the original large door openings are now in-filled but the location of original window and door openings are evident. These drawings were prepared by Mason Architects. Not to scale.
